Façade Inspection Comparative Study: Binocular, Close-up, and AI-assisted

by Katarzyna Burzynska, Nur Sila Gulgeç, Ken Maschke, and Badri Hiriyur

FAÇADE INSPECTION STUDY

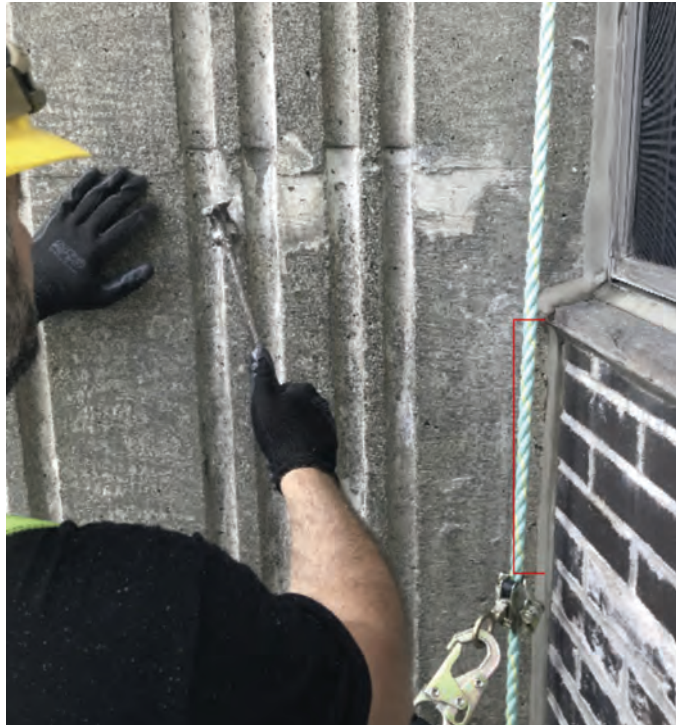
Fig. 3: False positive indication—lifeline detected as exposed rebar

- Multiple photos showing the same condition at a different angle due to the photos being manually taken with a digital camera. In the post-production process (described further as manual adjustment), doubled photographs were removed;
- Lifeline detected as exposed rebar. Most likely due to the shape of lifeline, there were several instances where it was detected as exposed rebar; and
- Spalls which exposed rebar showed double detections in several cases. Although not necessarily a wrong indication, this was manually adjusted to show spalls in deeper conditions and exposed rebar in more shallow, smaller conditions.

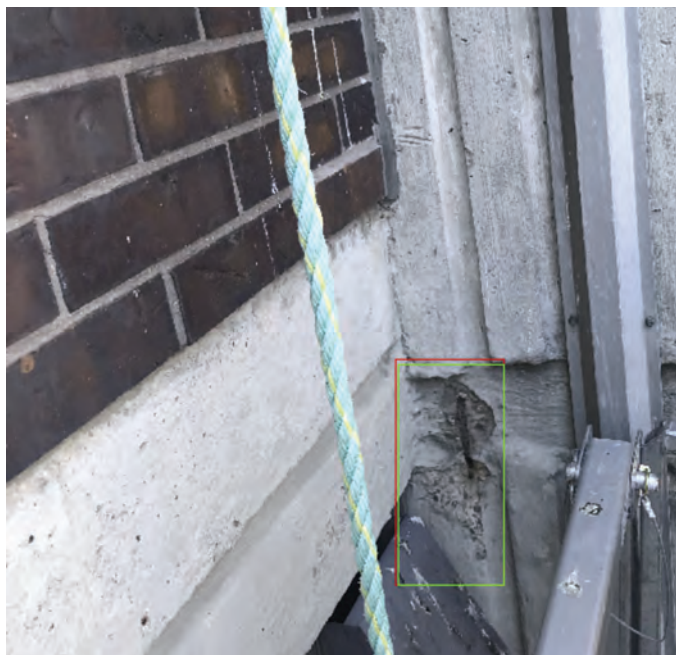
Fig. 4: Double positive indication—spall and exposed rebar

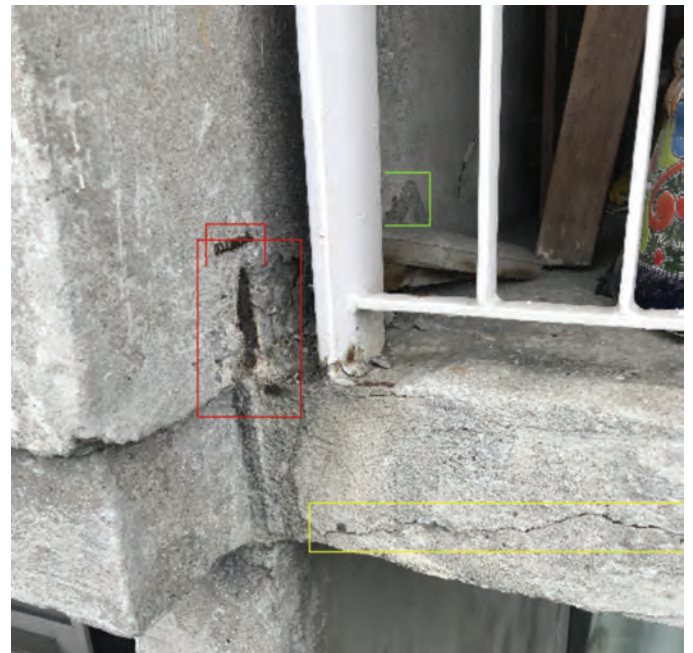
Fig. 5: Example of AI condition detection (red boxes display detected exposed rebar, green—spall, yellow—crack)

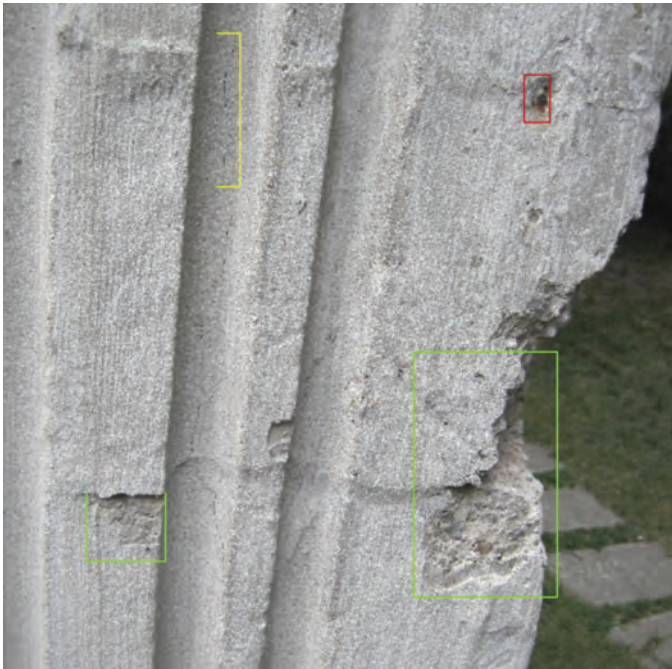
Fig. 6: Example of AI condition detection (red boxes display detected exposed rebar, green—spall, yellow—crack).

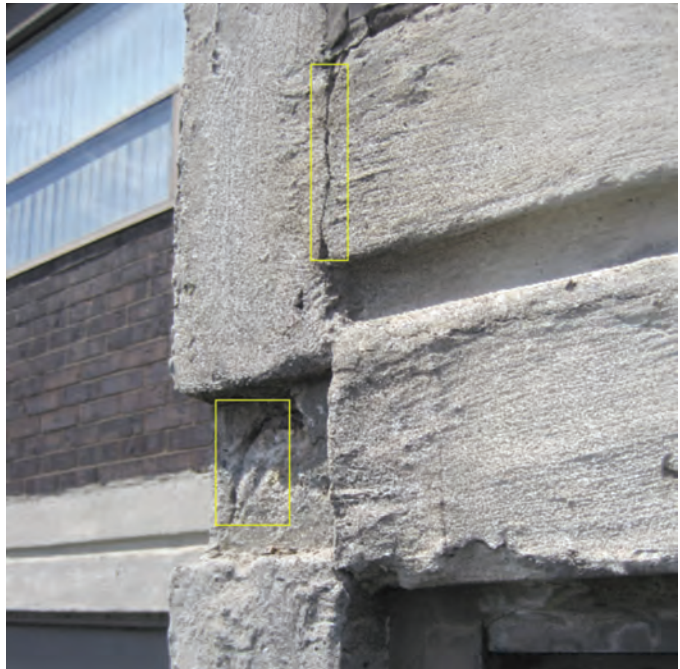
Fig. 7: Example of AI condition detection (yellow boxes display detected cracks)
